AFRL-PR-WP-TR-1998-2119

Investigation of TESCOM Driveshaft Assembly
Failure

Technology Evaluation Branch
Turbine Engine Division

October 1998

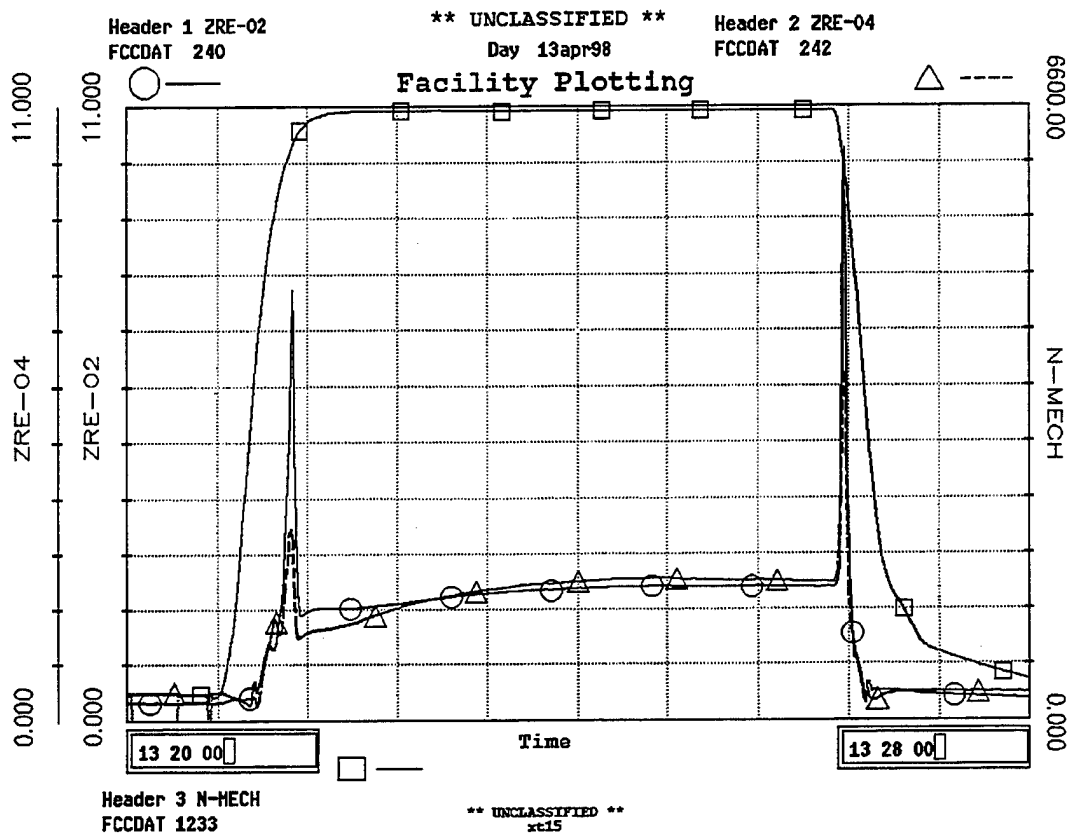
Figure 2.1. Jackshaft vibrations during the first MIN SPEED run.

On 13 April, 1998, two attempts were made to perform a compressor and facility mechanical checkout. During the first attempt, which started at 13:20, a stable MIN SPEED condition was successfully reached at 6544 rpm for the gearbox configuration used during this test. However, an apparent shaft critical speed was crossed during the acceleration to MIN SPEED. High vibrations were noted in jackshaft proximity probes at approximately 6150 rpm. Vibration amplitudes reached nearly 8 mils. The alarm limit is 5 mils. A MIN SPEED command was the prescribed action for this condition, Table 1.1, but it is unknown whether that command was issued by the control computers since variable speed control had not been obtained and the compressor was already accelerating to MIN SPEED. Vibrations dropped to approximately 2 mils after crossing the critical speed. The MIN SPEED condition was maintained for approximately 5 minutes before the facility control computers issued an E-STOP command. See Table 1.1. The critical speed was again observed as the rig decelerated to stop, with high vibrations in the jackshaft proximity probes at 6150 rpm. Vibration amplitudes at the critical speed during the deceleration reached more than 10 mils, greater than during the acceleration to MIN SPEED. No alarm was noted for this crossing since the E-STOP command had already taken effect. The run was concluded at 13:28. Figure 2.1 shows the proximity probe vibration amplitudes during the first MIN SPEED run. In the figure, headers ZRE-02 and ZRE-04 represent the jackshaft proximity probes.

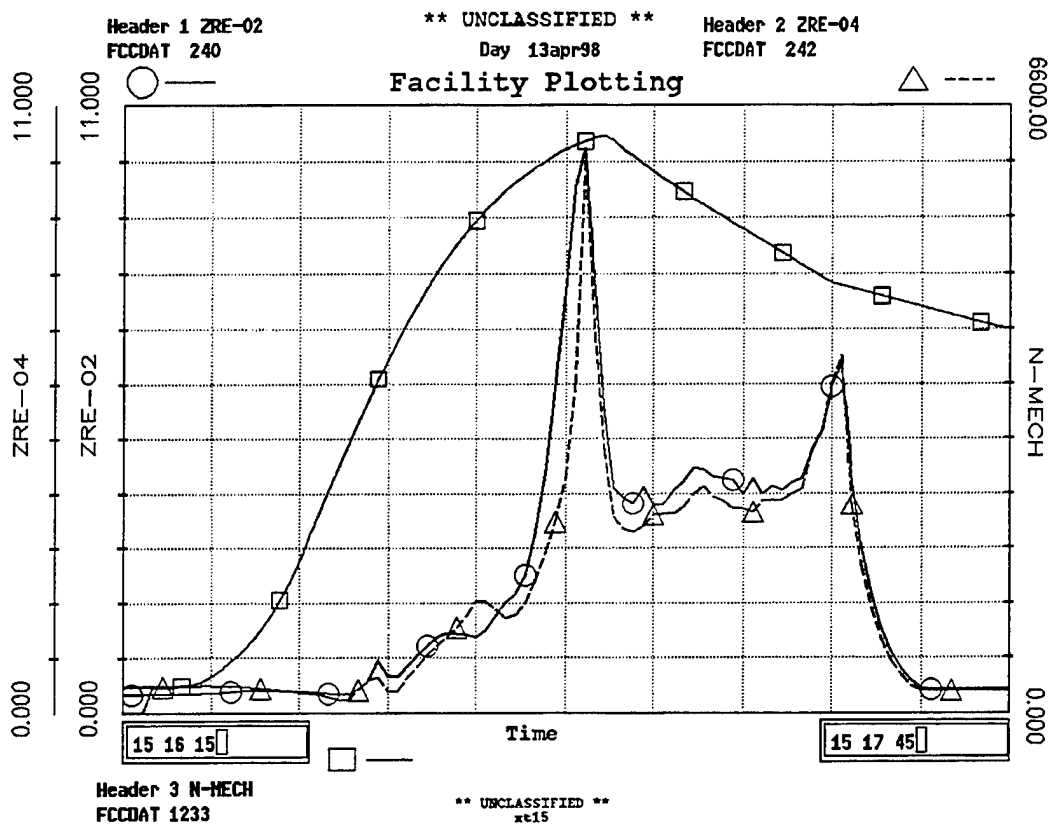
Figure 2.2. Jackshaft vibrations during the second MIN SPEED run.

The second attempt at mechanical checkout was started at 15:16. High vibrations again occurred near the 6150 rpm critical speed. However, the jackshaft proximity probes reached a sharp peak of more than 10 mils and suddenly dropped off to a steady amplitude of approximately 4 mils p-p. Drive system vibration levels during the second run are shown in Figure 2.2. Once again, ZRE-02 and ZRE-04 represent the proximity probes on the jackshaft. Proximity probes on the test compressor indicated vibrations in excess of 10 mils, and accelerometer amplitudes from the compressor suddenly dropped. Again, it is unknown whether the control computers issued a MIN SPEED command. Approximately 3 seconds after the change in signals, one of the programmable logic computers (PLC2) initiated an E-STOP command, and the compressor began to decelerate from 6250 rpm at a rate of approximately 70 rpm/sec. The reason for the E-STOP command from PLC2 has not been determined. Twenty-two seconds after the E-STOP command was issued, jackshaft proximity probes and compressor accelerometers suddenly blossomed again and then dropped to less than 1 mil p-p. Compressor proximity probes dropped to less than 5 mil p-p. Strain gage signals from the test compressor also ended at this time. The gearbox and compressor speed signals began to diverge, and each coasted to stop uneventfully at different rates. The MIN SPEED condition was not reached during the second run, which ended at approximately 15:18. Vibration amplitudes will be discussed in more detail in Section 3 of this report.

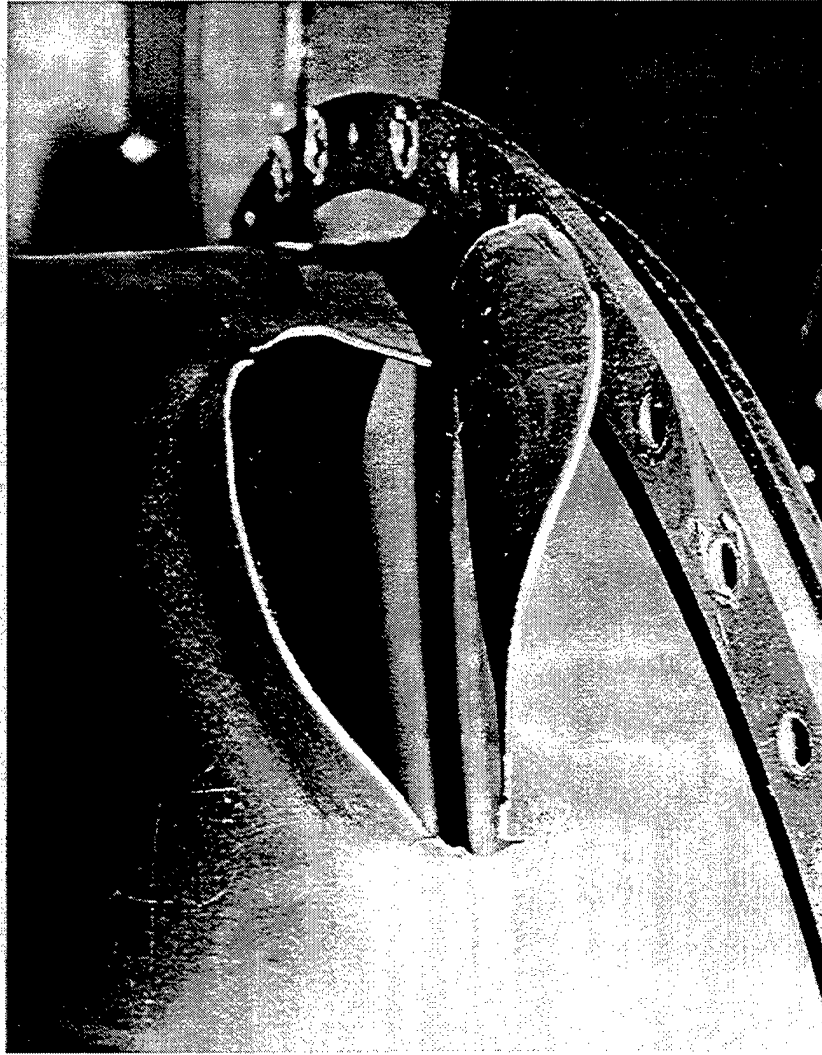
Figure 3.1. Photograph of hole in inner exit flow path.

A visual inspection of the test compressor and drive system was performed. During visual inspection from the gearbox area, pieces of the driveshaft assembly could be seen lying in the duct comprising the inner exit flow path. The outer exit flow path was opened, and an oval hole measuring 6 inches by 2.5 inches was found in the inner exit flow path at about the 4 o'clock position, aft looking forward. A photograph of the hole is shown in Figure 3.1. The inner exit flow path was opened, and the driveshaft assembly was found in three pieces. Two of these pieces were lying side by side in the bottom of the inner exit flow path, and the third piece, the spline portion of the spline shaft adapter, was still in the TESCOM main shaft. The pieces of the driveshaft assembly were removed from the test chamber for detailed inspection. A photograph of the pieces recovered from the inner exit flow path is shown in Figure 3.2. The facility drive system was also inspected in detail.

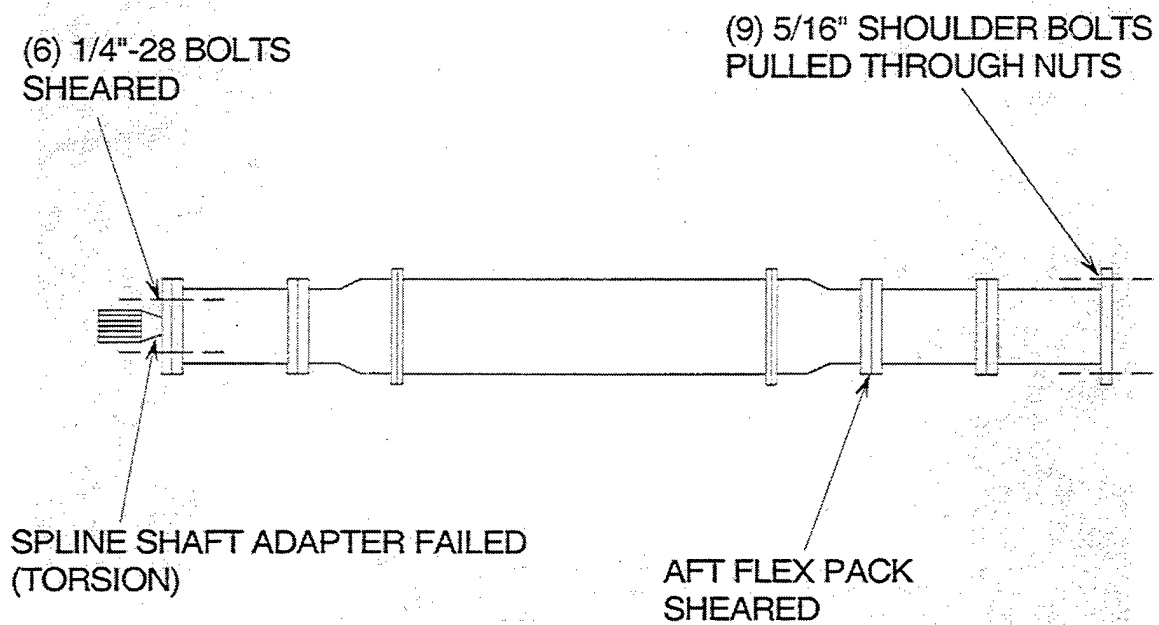
Figure 3.3. Driveshaft assembly failure points.

Inspection of the driveshaft assembly revealed three points of failure. These are shown in Figure 3.3. One of these was the connection point between the high speed jackshaft and the 9-inch spacer used in the driveshaft assembly. At this point, nine (9) 5/16 inch shoulder bolts were pulled axially through the nuts securing them. A photograph of the spacer at this point is shown in Figure 3.4. The corresponding part of

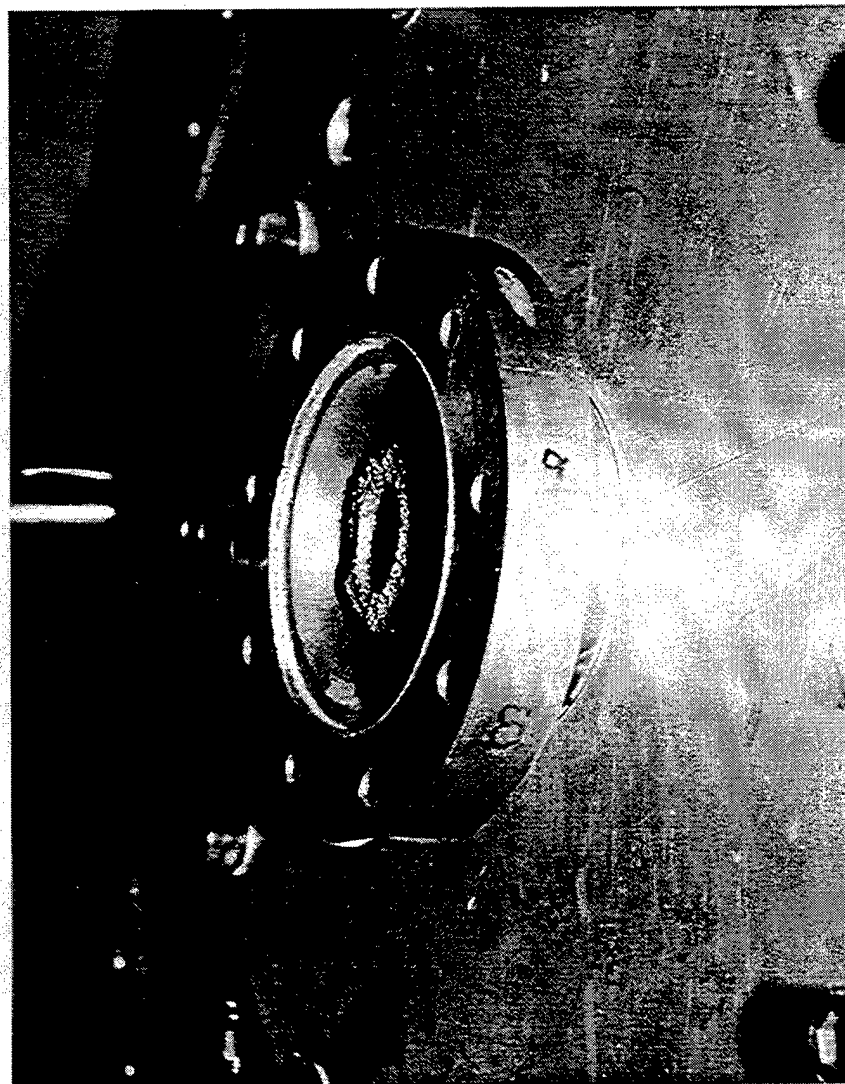
Figure 3.5. High speed jackshaft at driveshaft assembly interface.

the jackshaft is shown in Figure 3.5. The coarse gray material at the at the end of the jackshaft and in the center of the spacer in the photographs is the foam filler used to secure the strain gage leads. A second point of failure was the aft flex pack of the Kop-Flex coupling, which sheared as indicated in Figure 3.3. The mating sections of the failed aft flex pack are shown in Figures 3.6 and 3.7. The thin metal sheets on the interior of the pack were essentially shredded. Once again, the coarse material in the center of the flex pack pieces is the foam material used to secure the strain gages. The final point of failure was the neck of the spline shaft adapter connecting the driveshaft to the compressor shaft. This location is indicated in Figure 3.3. The neck of the spline shaft adapter failed in torsion, and the six (6) ¼ inch - 28 bolts securing the spline shaft adapter to adapter 1 and the forward end of the Kop-Flex coupling were sheared. Figure 3.8 shows a photograph of the portion of the adapter still connected to adapter 1 and the Kop-Flex coupling. The spline portion of the spline shaft adapter and bolts remained in the compressor main shaft, as shown in Figure 3.9. These were easily removed with no apparent damage to the female spline in the compressor shaft.

The facility drive system was inspected for damage. The end of the high speed jackshaft that mated with the driveshaft assembly has a precision female rabbet measuring 3.600/3.6016 inches diameter. The rabbet had been worn out to approximately 3.680 inches, depending on where the measurement was taken. This section of the high speed jackshaft was removed for repair. The labyrinth seal was removed and found to have rubbed against the high speed jackshaft. The damage was minor and repairable.

The damaged areas of the drive system were repaired. The rabbet end of the high speed jackshaft was welded using AMS 4130 to build up the damaged surface and machined to original tolerances. The rubbed labyrinth seal was cleaned up. The pads on the no. 1 pedestal bearing were replaced as a precautionary measure due to the high vibrations experienced during testing. The drive system was reassembled and a no-load test was performed. No problems were indicated during testing. A new Kop-Flex coupling was designed and ordered.

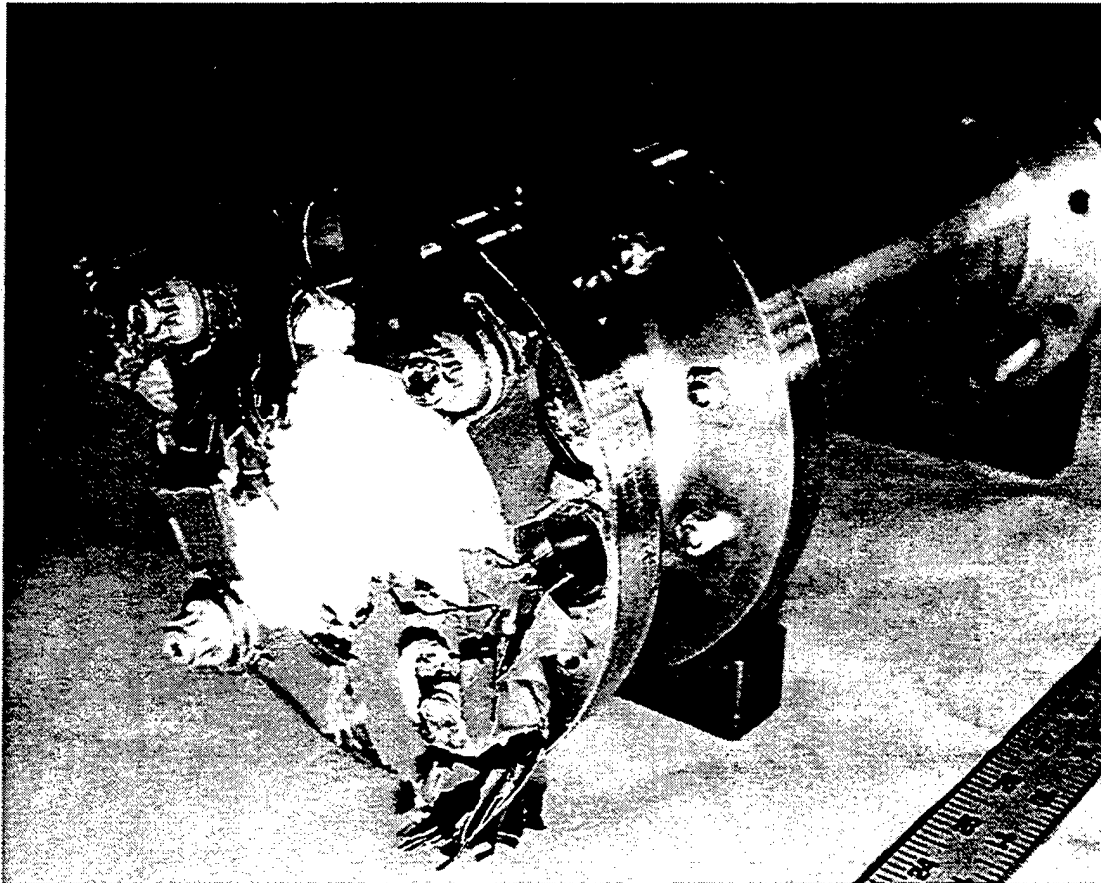
Figure 3.6. Aft end of failed flex pack.

From the data presented, the failure probably initiated at the aft flex pack, which began to whirl off-axis. Initiation of this subsynchronous whirl and the severe imbalance it caused corresponds to Event #1 described in Section 3.2. The whirl produced the 0.5/rev frequency noted in the data from the proximity probes. The whirl also pulled the bolts at the connection point between the high speed jackshaft and the 9-inch spacer. After 25 seconds in this state, the flex pack failed entirely, corresponding to Event #2 described in Section 3.2. The weight of the coupling fragment and spacer finished pulling the bolts from the jackshaft, allowing these pieces to fall to the bottom of the inner exit flow path. In addition, the angular momentum of the Kop-Flex coupling apparently snapped off the spline at the neck of the spline shaft adapter when the flex pack suddenly failed. At some point during the failure, the whirling end of the Kop-Flex coupling likely struck the wall of the inner exit flow path, resulting in the gash. Finally,

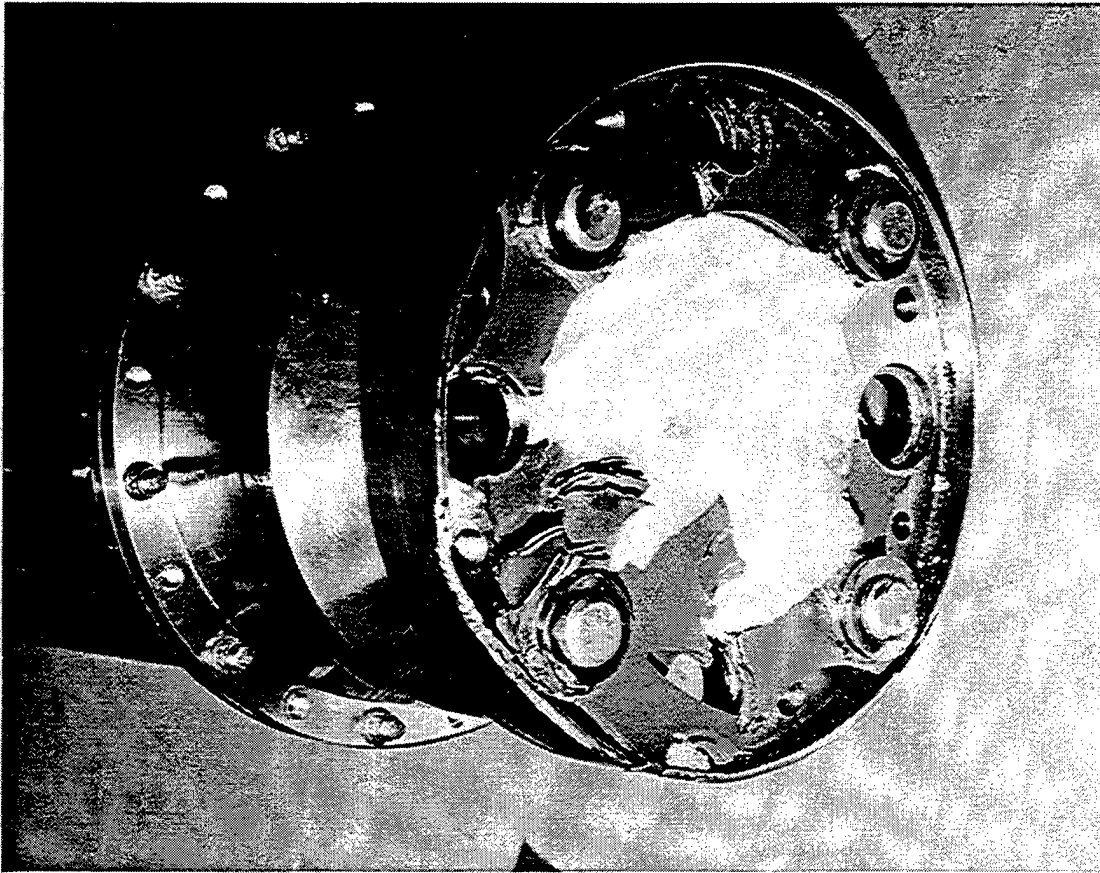
Figure 3.7. Forward end of failed flex pack.

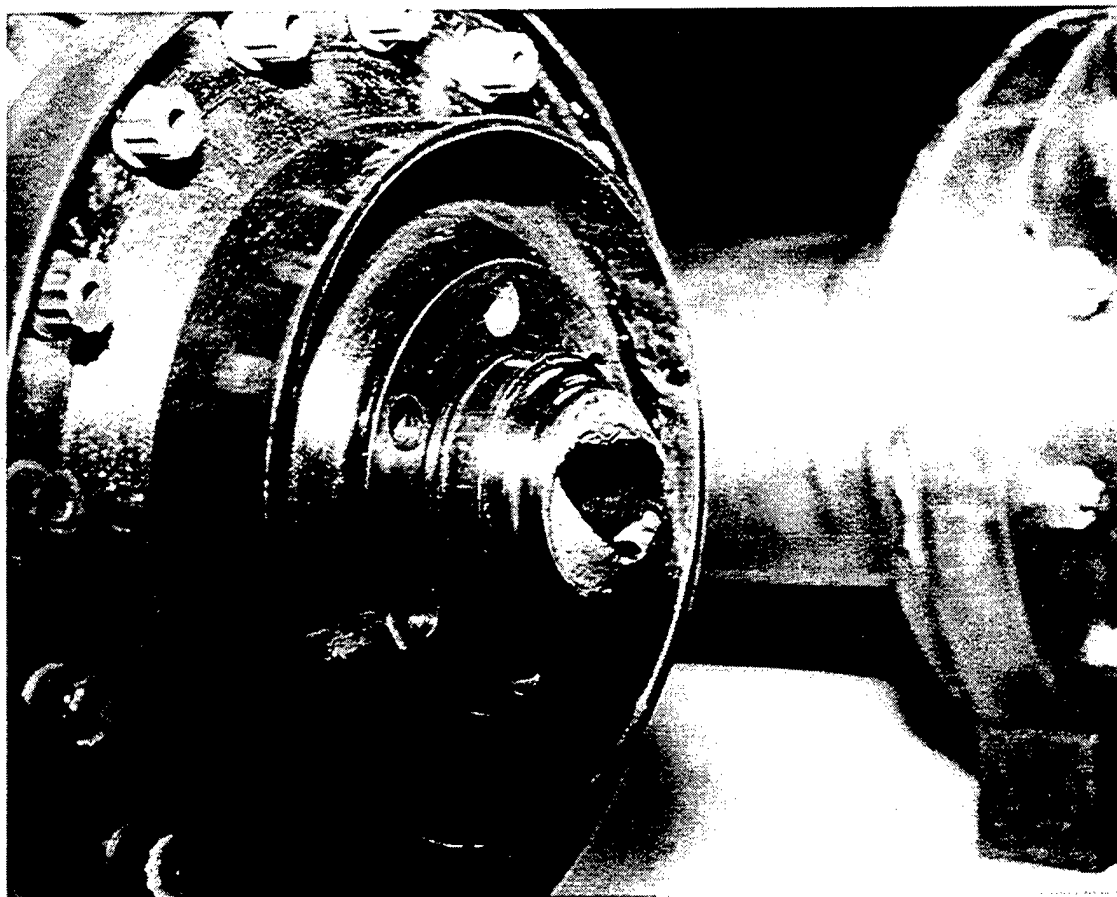
The spline portion of the spline shaft adapter removed from the compressor main shaft is shown in Figure 3.10. The fracture surface was inspected under 10X magnification, Figure 3.11. No striations indicative of cyclic loading were visible. Therefore, the failure was apparently a result of a single overload. Some ductile deformation, seen in Figure 3.8, occurred prior to final brittle fracture.

Figure 3.8. Aft portion of failed spline shaft adapter which remained with the drive system assembly.

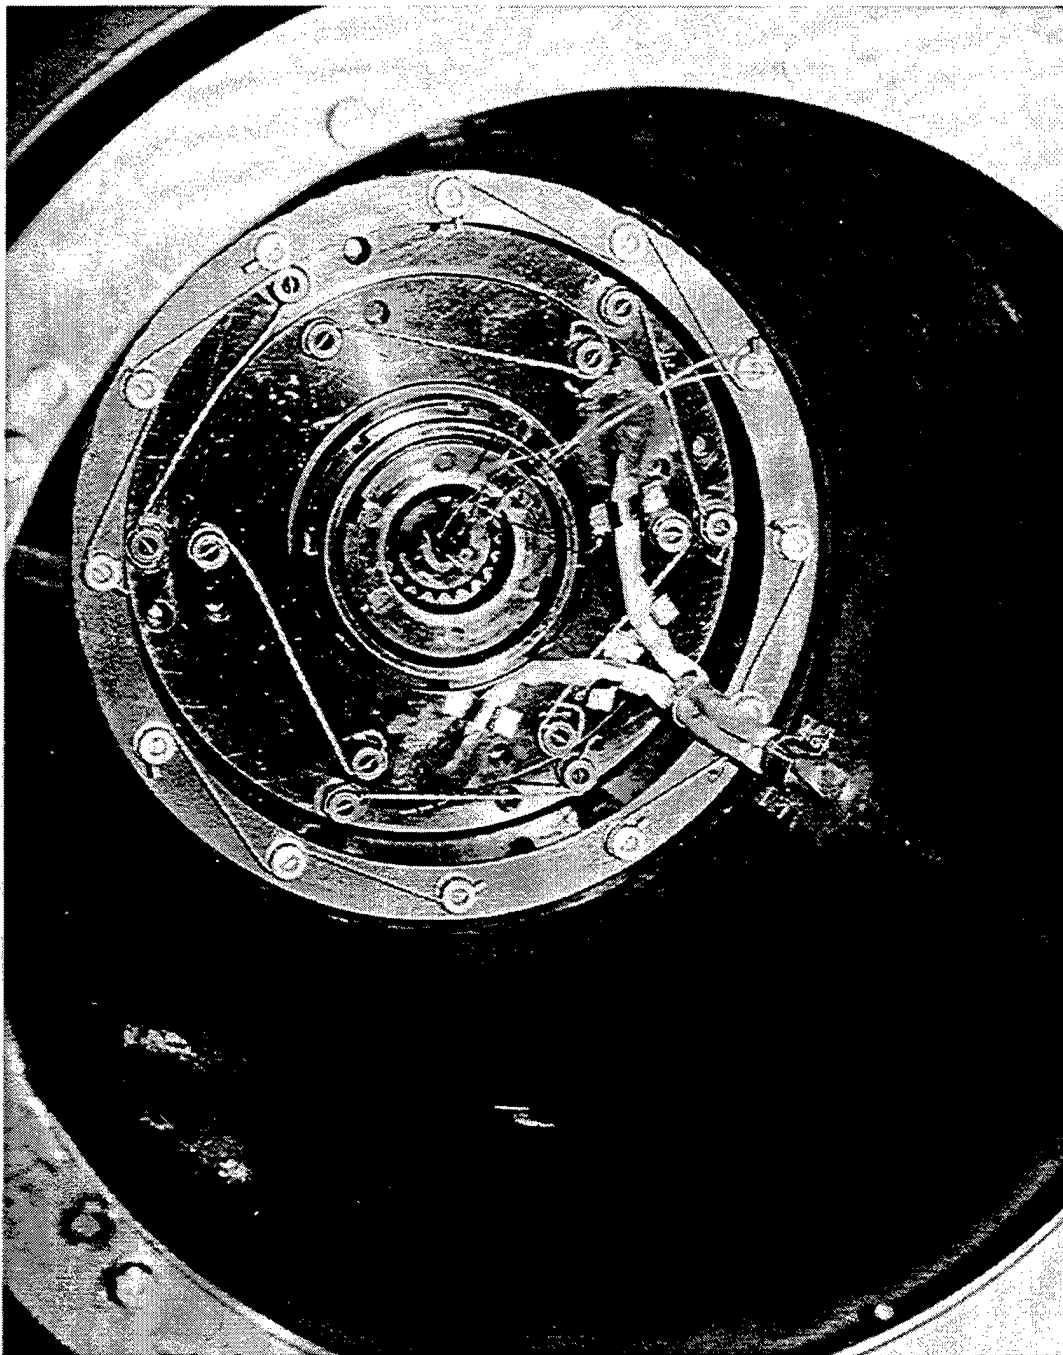
Figure 3.9. Spline portion of the spline shaft adapter and bolts in compressor main shaft.

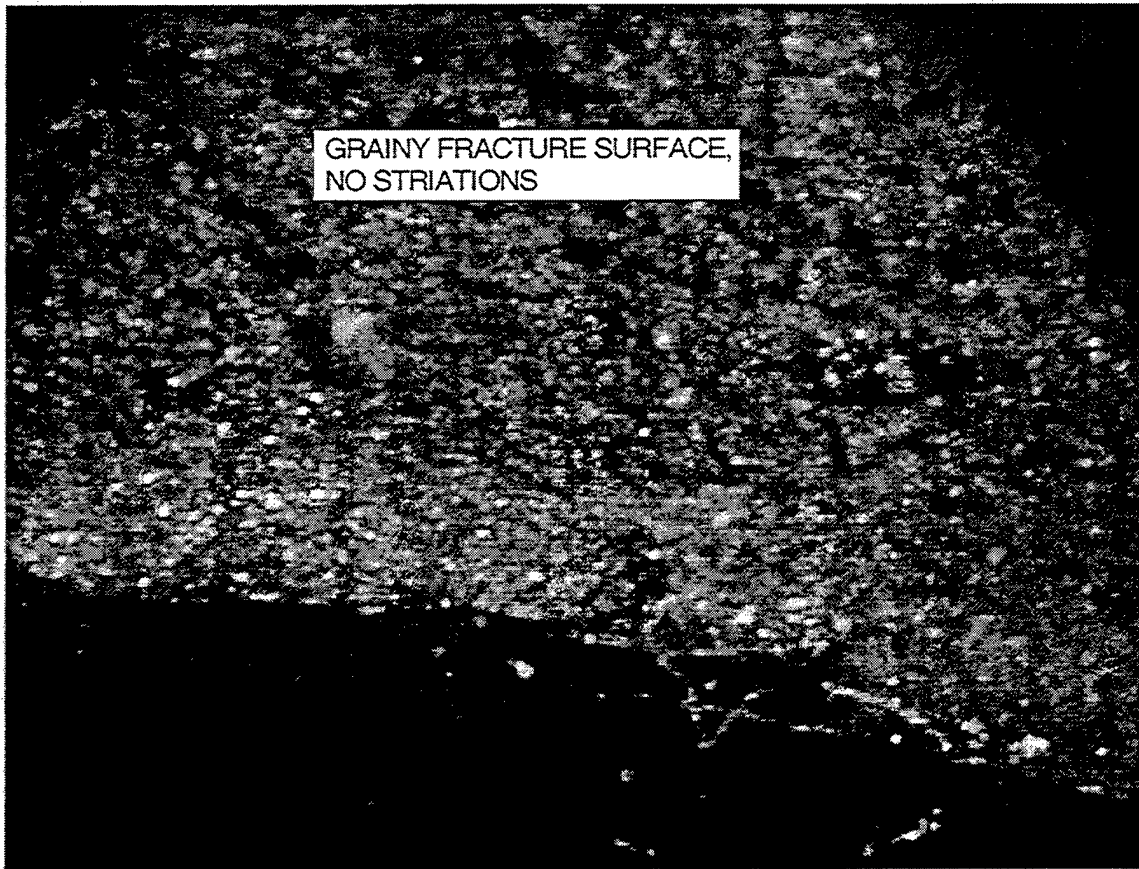
GRAINY FRACTURE SURFACE,
NO STRIATIONS

Figure 3.11. Fracture surface of the spline shaft adapter under 10X microscope.

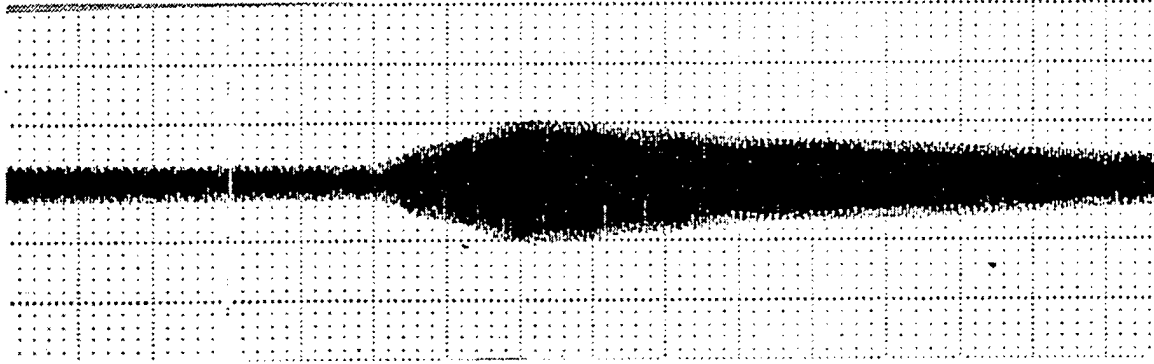
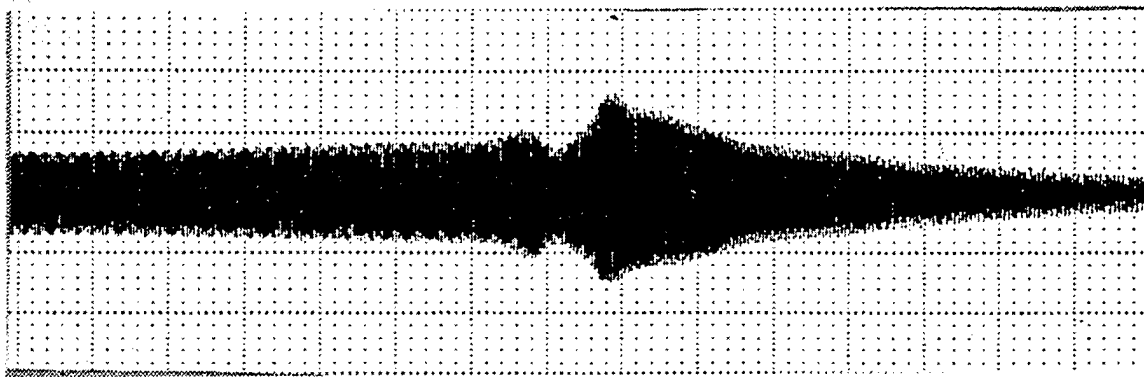
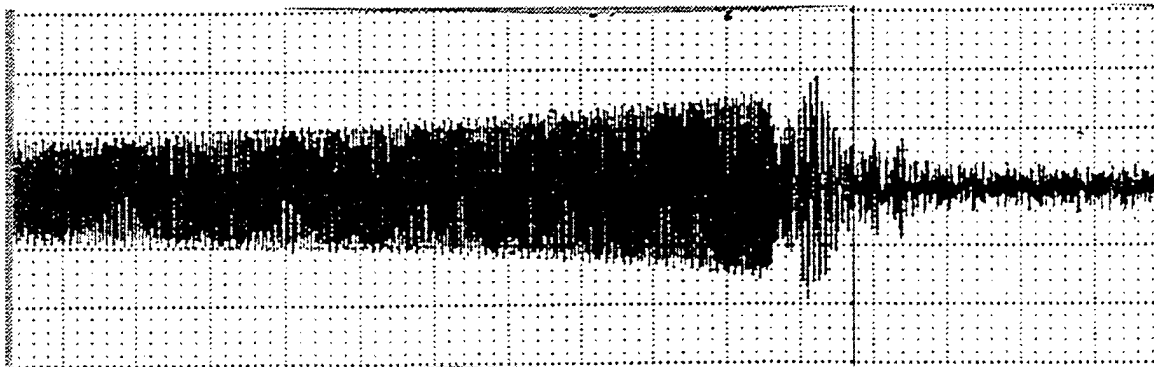
As previously discussed, proximity probes on the jackshaft indicated high vibrations indicative of a shaft critical speed at approximately 6150 rpm. The responses from one of these probes are shown for both MIN SPEED runs in Figure 3.12. The amplitude of the vibration at the shaft 1/rev frequency was approximately 7.75 mils during the acceleration phase of the first run and approximately 10 mils during deceleration. In both cases, the vibration amplitude was well above the alarm limit of 5 mils set for the test. Moreover, the maximum amplitude of the proximity probe increased with each successive transit through this critical, indicating cumulative damage to the spacer/coupling. This result demonstrates that damage initially occurred during the first

MIN SPEED run. The driveshaft assembly passed through this critical three times before failure.

Figure 3.12. High speed jackshaft proximity probe time histories showing amplitude increase with each pass.

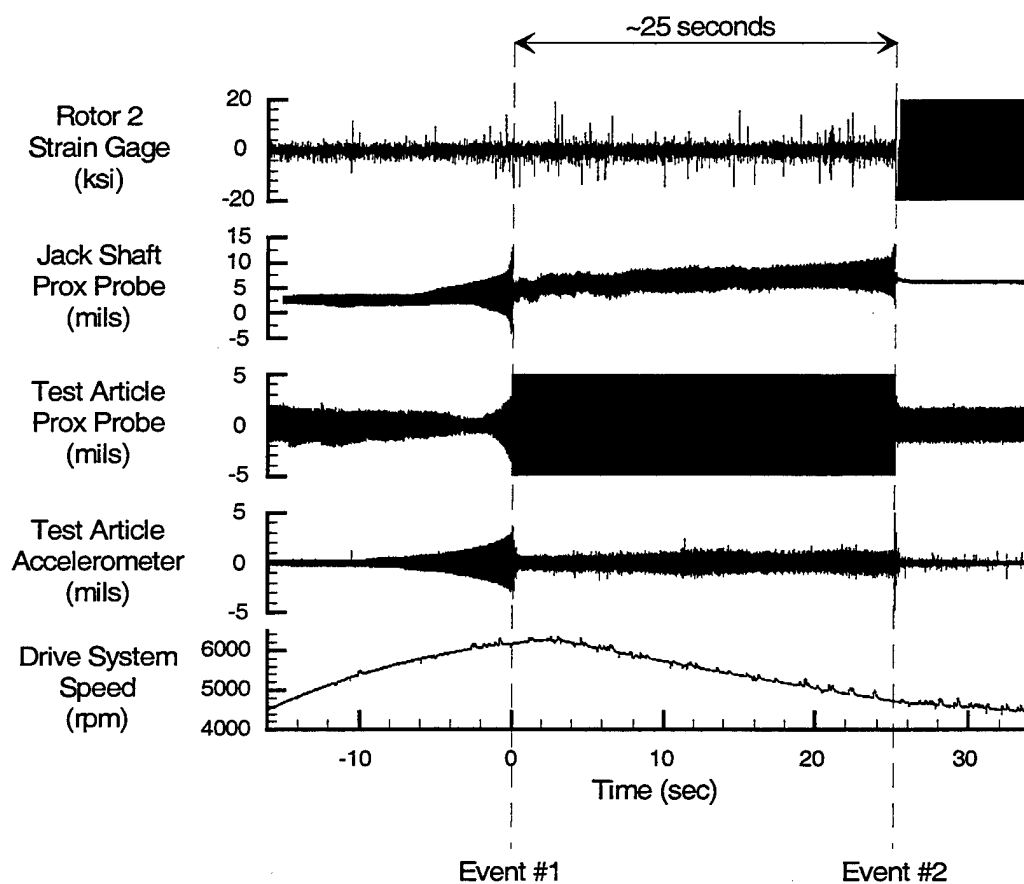
Figure 3.13. Time histories of pertinent transducers.

Data from the second MIN SPEED run indicated that the failure consisted of two distinct events. The time histories of several pertinent signals are shown in Figure 3.13 to confirm this. During the acceleration to minimum speed, accelerometer and proximity probe signals began to rise steadily during the period from -2 seconds to 0 seconds. During this same period, test compressor and drive system speeds were synchronous at approximately 6100 to 6150 rpm. Compressor accelerometers and proximity probe signals all indicated a maximum of approximately 5 mils p-p displacement. Drive system proximity probes near the jackshaft blossomed sharply to over 15 mils p-p. Facility monitoring computers only detected 10 mils p-p (Figure 2.2) because the blossom occurred too rapidly to be accurately computed with fast Fourier transform techniques used in the data processing algorithm. All of the instrumentation signals were dominated by the 1/rev frequency.

The data shown in Figure 3.13 indicates that the failure began with Event #1 at 0 seconds. At that point, the flex pack on the aft end of the Kop-Flex coupling began to fragment. For approximately 25 seconds, or 1100 to 1250 cycles according to the proximity probes, the damaged flex pack introduced a severe imbalance to the system, causing a subsynchronous backward-traveling whirl as evidenced by the 0.5/rev frequency in the proximity probe signals. After 25 seconds, Event #2 occurred. The flex pack joint failed entirely, leading to the failures at the spline shaft adapter and at the interface between the 9-inch spacer and the jackshaft. Once decoupled, the test article and drive system coasted down separately to 0 rpm. Since the driveshaft assembly served as the strain gage wireway, strain gage leads were broken and strain gage signals were lost when the driveshaft assembly failed.
